Hempcrete building and Solar thermal reincarnation

Dorje Denma Ling Shambala center, Tatamagouch, Nova Scotia.

A solar thermal story

A study in panel degradation

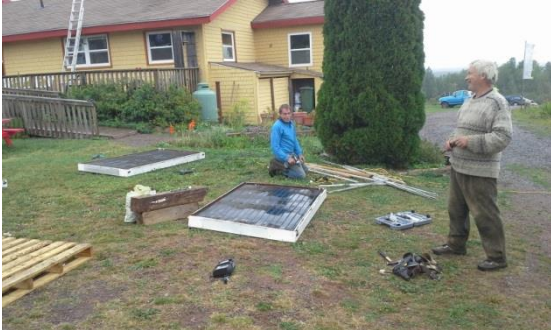
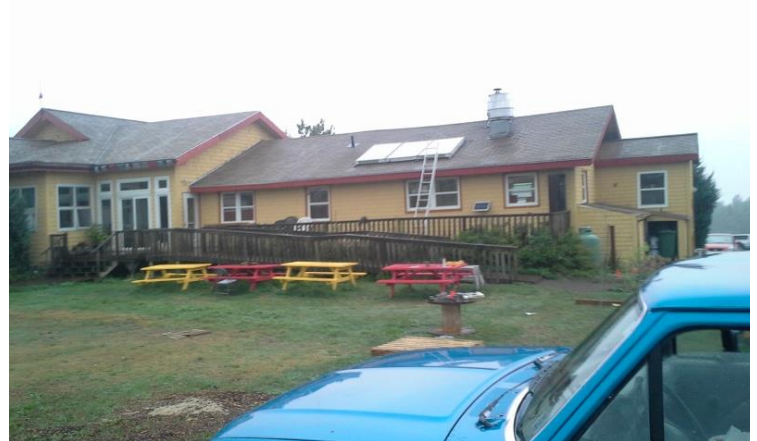
First obstacle: the frame that holds the glass on was fastened by the original manufacturer using steel screws! We had to grind off the screws. Fortunately, the galvanic principle left the aluminum frame in fine condition.

The seal between the glass and the channel in the frame was intact and appeared to be made from EPDM.

The Iso cyanic foam had been painted with white paint that was flaked off completely leaving the foam exposed to radiation that had badly deteriorated it.

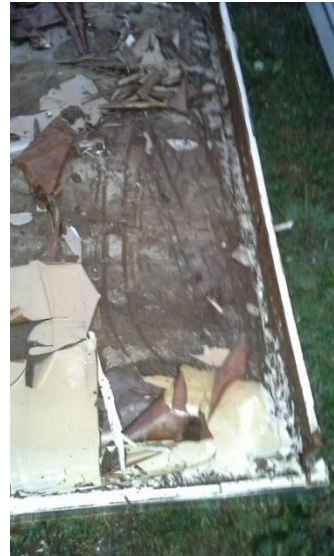
Most notably, the copper "absorber plate" was mostly or completely detached from the riser tubing! It had been soldered to the absorber plate with lead solder that completely failed. There would be no heat transfer without re attaching the risers to the plate.

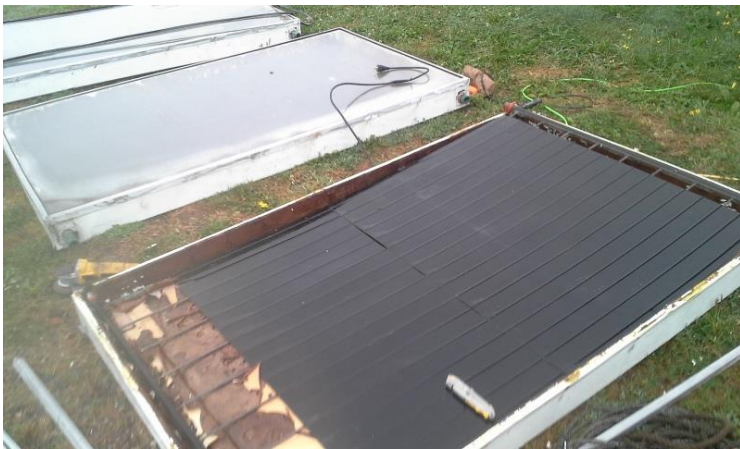
The most difficult part of soldering the plate on was the rain!!! It was also very difficult to keep the copper sheet flat because when the torch, however lightly, was applied, the sheet tended to bow up.

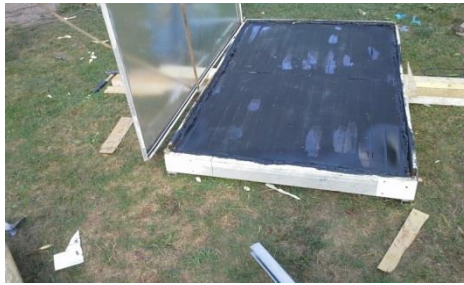
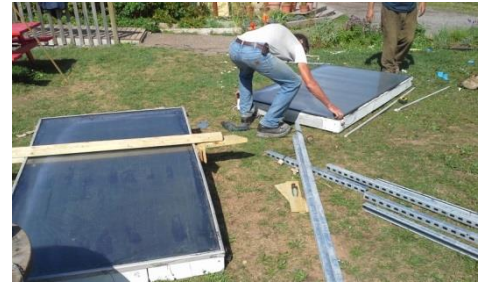
The frame had lost its' shape during operations which presented challenges when fitting the glass back on. The aluminum frame that held the glass was screwed back onto the box with stainless steel screws.
