Hempcrete building and Solar thermal reincarnation

Dorje Denma Ling Shambala center, Tatamagouch, Nova Scotia.

A solar thermal story

A study in panel degradation

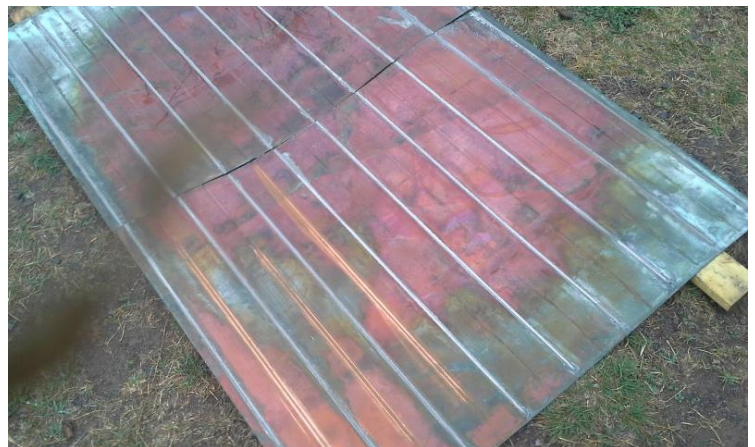
The most difficult part of soldering the plate on was the rain!!! It was also very difficult to keep the copper sheet flat because when the torch, however lightly, was applied, the sheet tended to bow up.

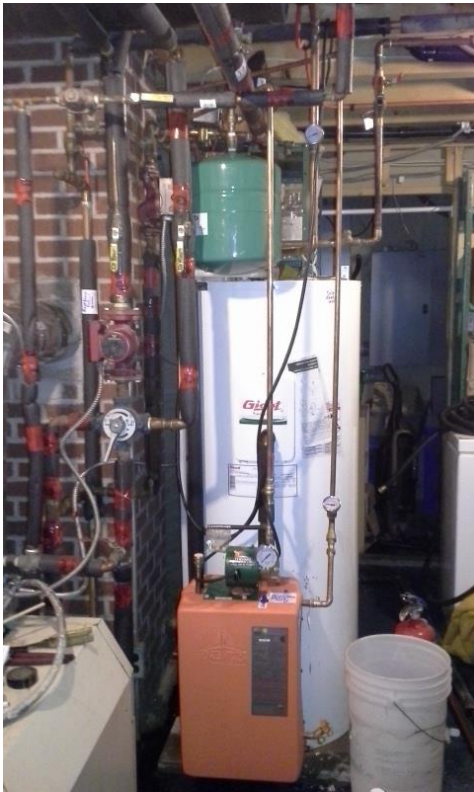
The "E Mag" pump is self-priming but it was raining on commissioning day. We manually filled the system and I am told it started right up on the next sunny day (PV powered). I am pretty sure it wasn't quite that simple but Billy had a great understanding of hydronics and knew just what to do.

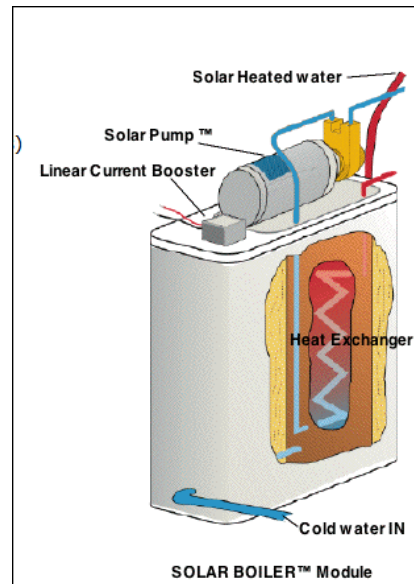
The Thermodynamics heat exchanger and 12 volt pump module has two copper cylinders within. One of these is a tube in shell heat exchanger containing 3/8 tubing with 6.5 sq. ft. surface passing through it in coil form. At best, this heat exchanger will be slightly under sized. The other chamber is a pressure chamber for the heat transfer fluid (propylene glycol), it acts as a small expansion tank. One can see by the placement of an extra expansion tank that I am hopeful the heat exchanger and domestic tank will be too small. The Green Guard, 72 gallon domestic water tank is prepared to conveniently couple to the pump module with unions. DHW demand is quite high during the day at the facility, especially in the summer.

Solar heated water moves from the heat exchanger into the tank through thermo dynamic convection.

The 3/8" solar pipe connections were replaced with 1/2" connections. The fluid capacity of the solar loop is 3.5 gallons.
